TECHNICAL NOTE

No. 1790

INVESTIGATION OF ICING CHARACTERISTICS OF TYPICAL
LIGHT-AIRPLANE ENGINE INDUCTION SYSTEMS

Lewis Flight Propulsion Laboratory
Cleveland, Ohio

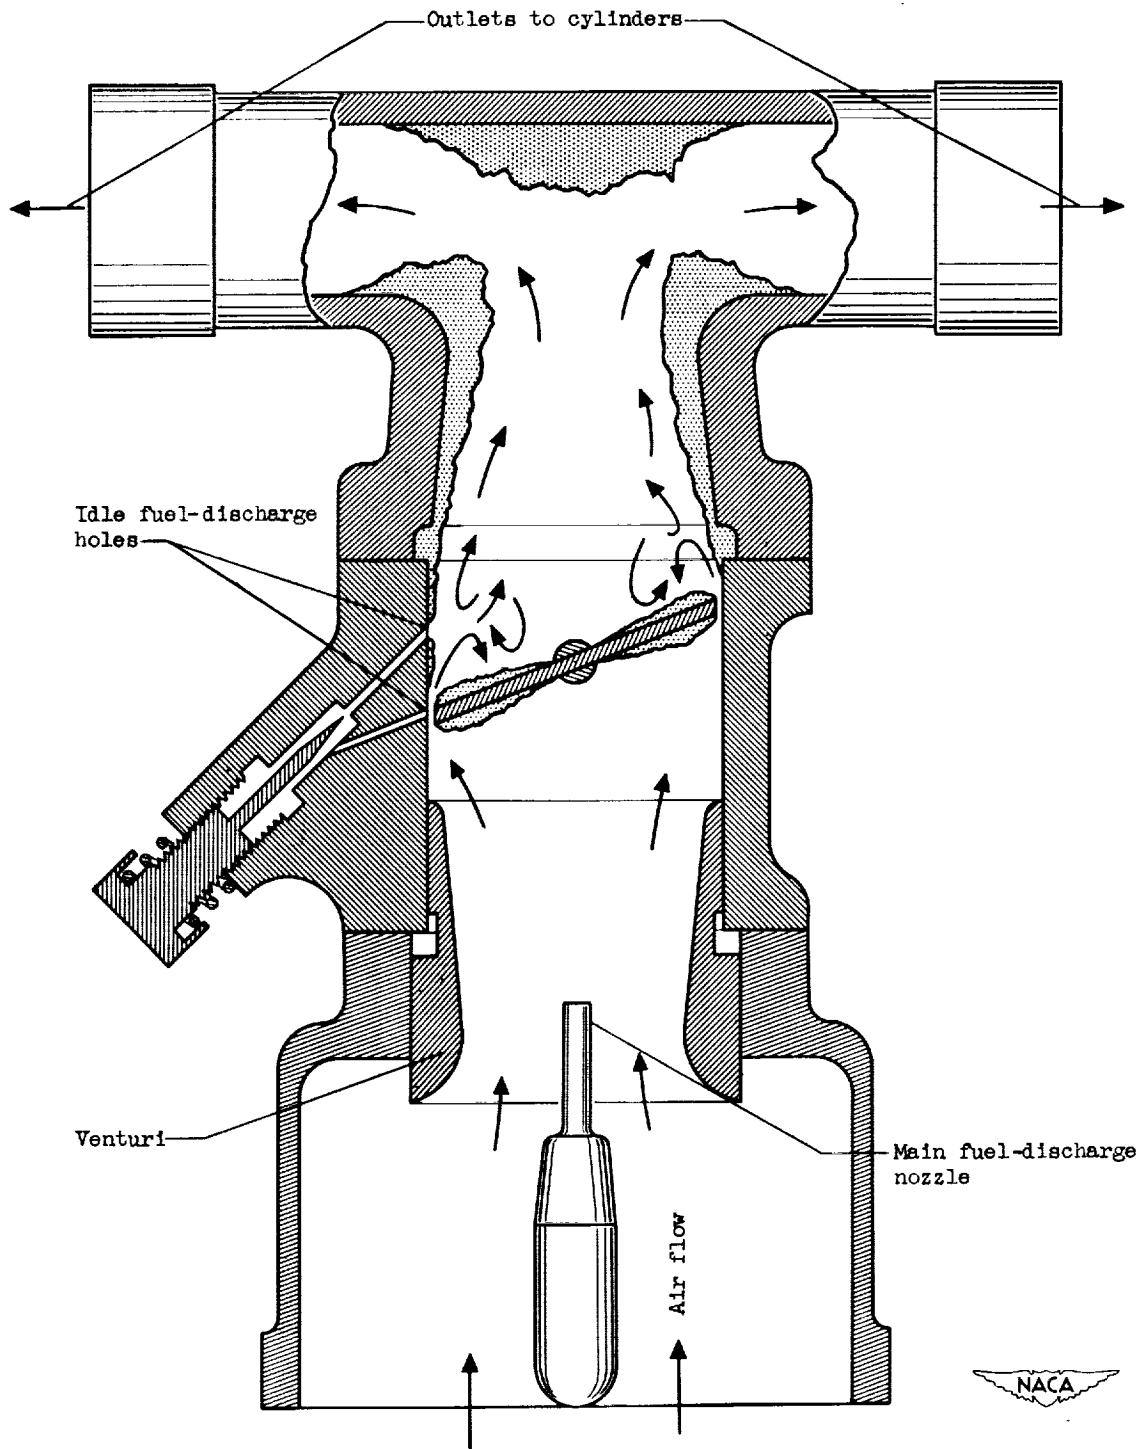
Observed locations of ice formation at glide-power conditions are shown in the sectional view of the carburetor and the manifold of figure 2. The throttle and the throttle body downstream of the throttle are most susceptible to ice formation and in the range of serious icing conditions ice was occasionally observed to build down from the top of the manifold and out from the walls of the manifold riser in sufficient quantities to block the riser passage completely.

Figure 2. - Schematic diagram of float-type carburetor and manifold showing typical ice formation at glide-power throttle setting.

A limited investigation made with a jacketed throttle body, a heated hollow throttle plate, and a jacketed manifold, with warm water as a heating medium showed that for complete icing protection

of the critical parts a maximum heat input of approximately 2000 Btu per hour was required. This condition occurred at high-cruise power with a carburetor-air temperature of 35° F, which was approximately the low temperature limit of the serious-icing range. The throttle plate required approximately 800 Btu per hour and the remaining heat was divided approximately equally between the throttle body and the manifold.

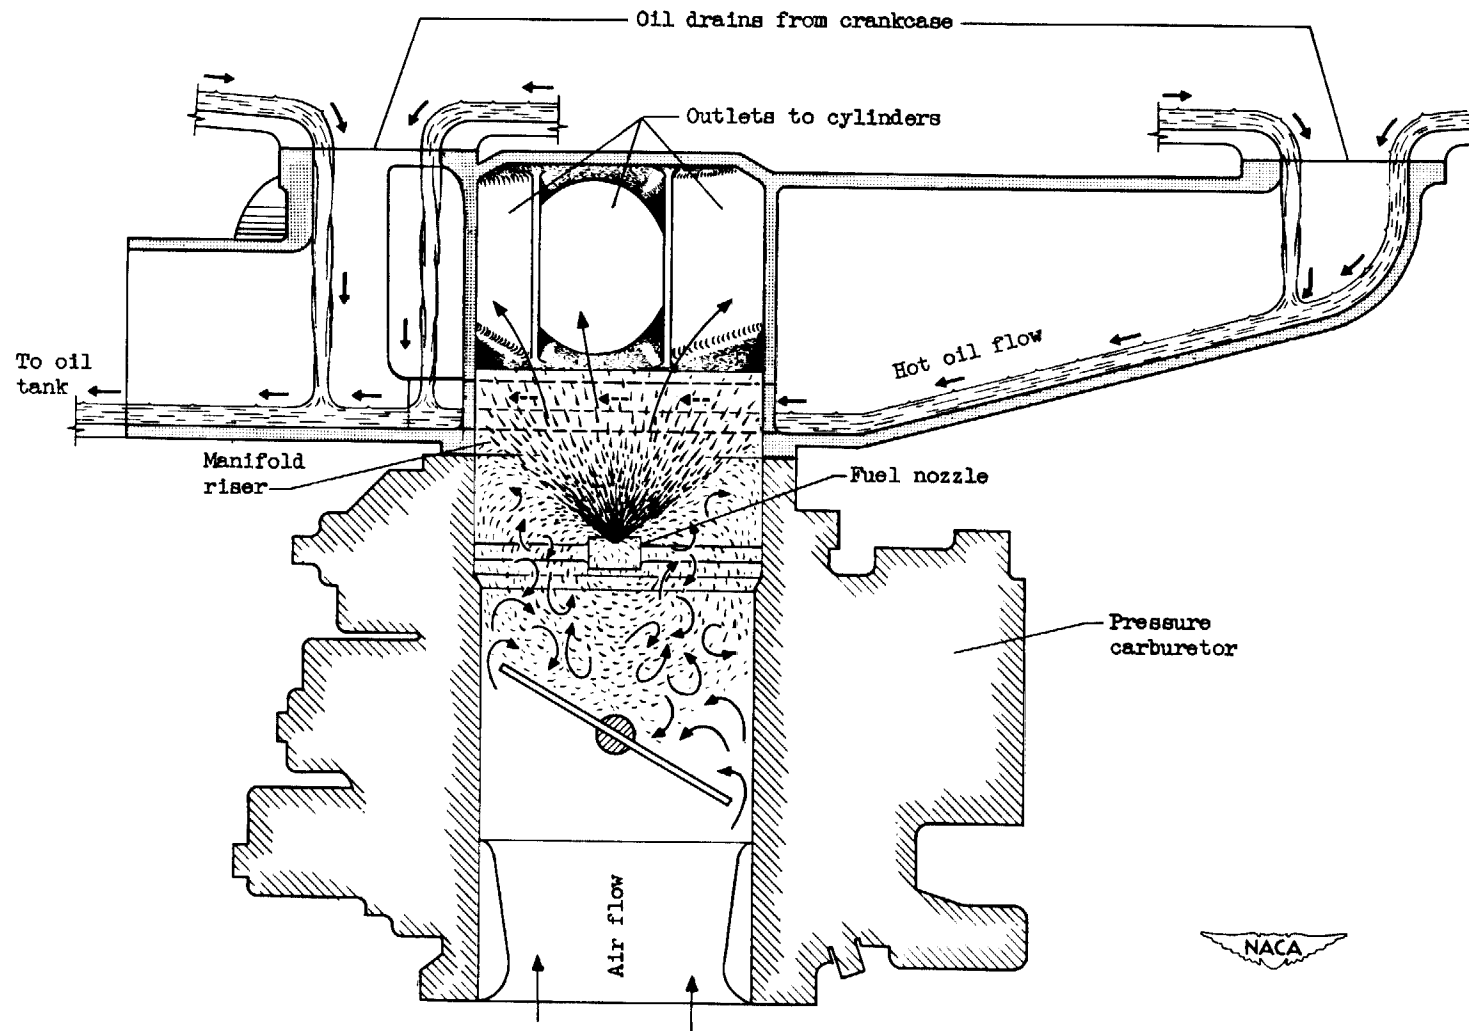
At low-cruise power, icing of the system was confined almost entirely to the top or ceiling of the manifold directly above the riser from the carburetor. Very little eddying of the fuel spray occurred and, as a result, no ice formed on the throttle. At glide power, the manifold icing was similar to that encountered at cruise power, but heavy frost and ice formed on both the top and the bottom and on the edges of the throttle plate. Slight icing on the fuel-discharge nozzle was occasionally visible at glide power, but was not found to be serious.

Several instances of extremely rich fuel-air ratios resulted at glide power in the serious-icing range and the air flow was reduced one-third or more. This effect was due to the fact that in the idle-speed range the fuel flow is controlled by the position of the idle needle valve, which in turn is mechanically operated by a linkage to the throttle. The fuel flow is therefore a function of throttle position and remains constant while the air flow is reduced by ice formation on the throttle, which results in a rich mixture.

(a) Schematic diagram of carburetor and manifold showing eddying of fuel spray at glide-power throttle position.

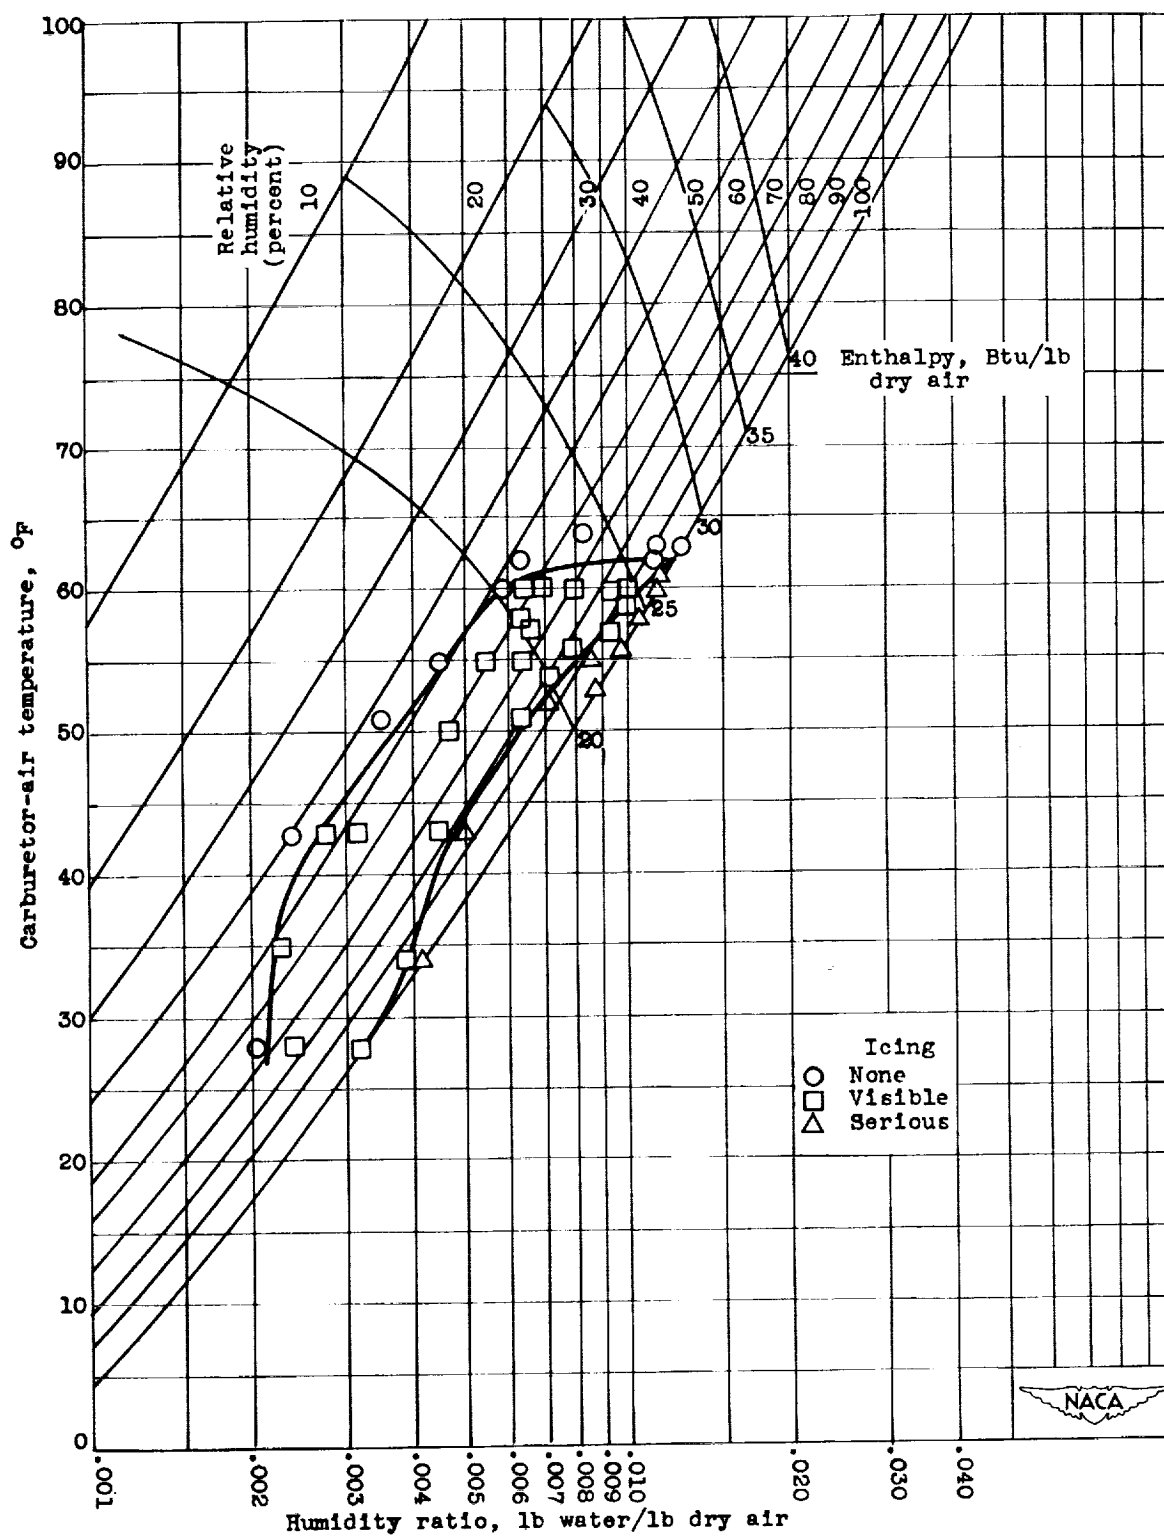
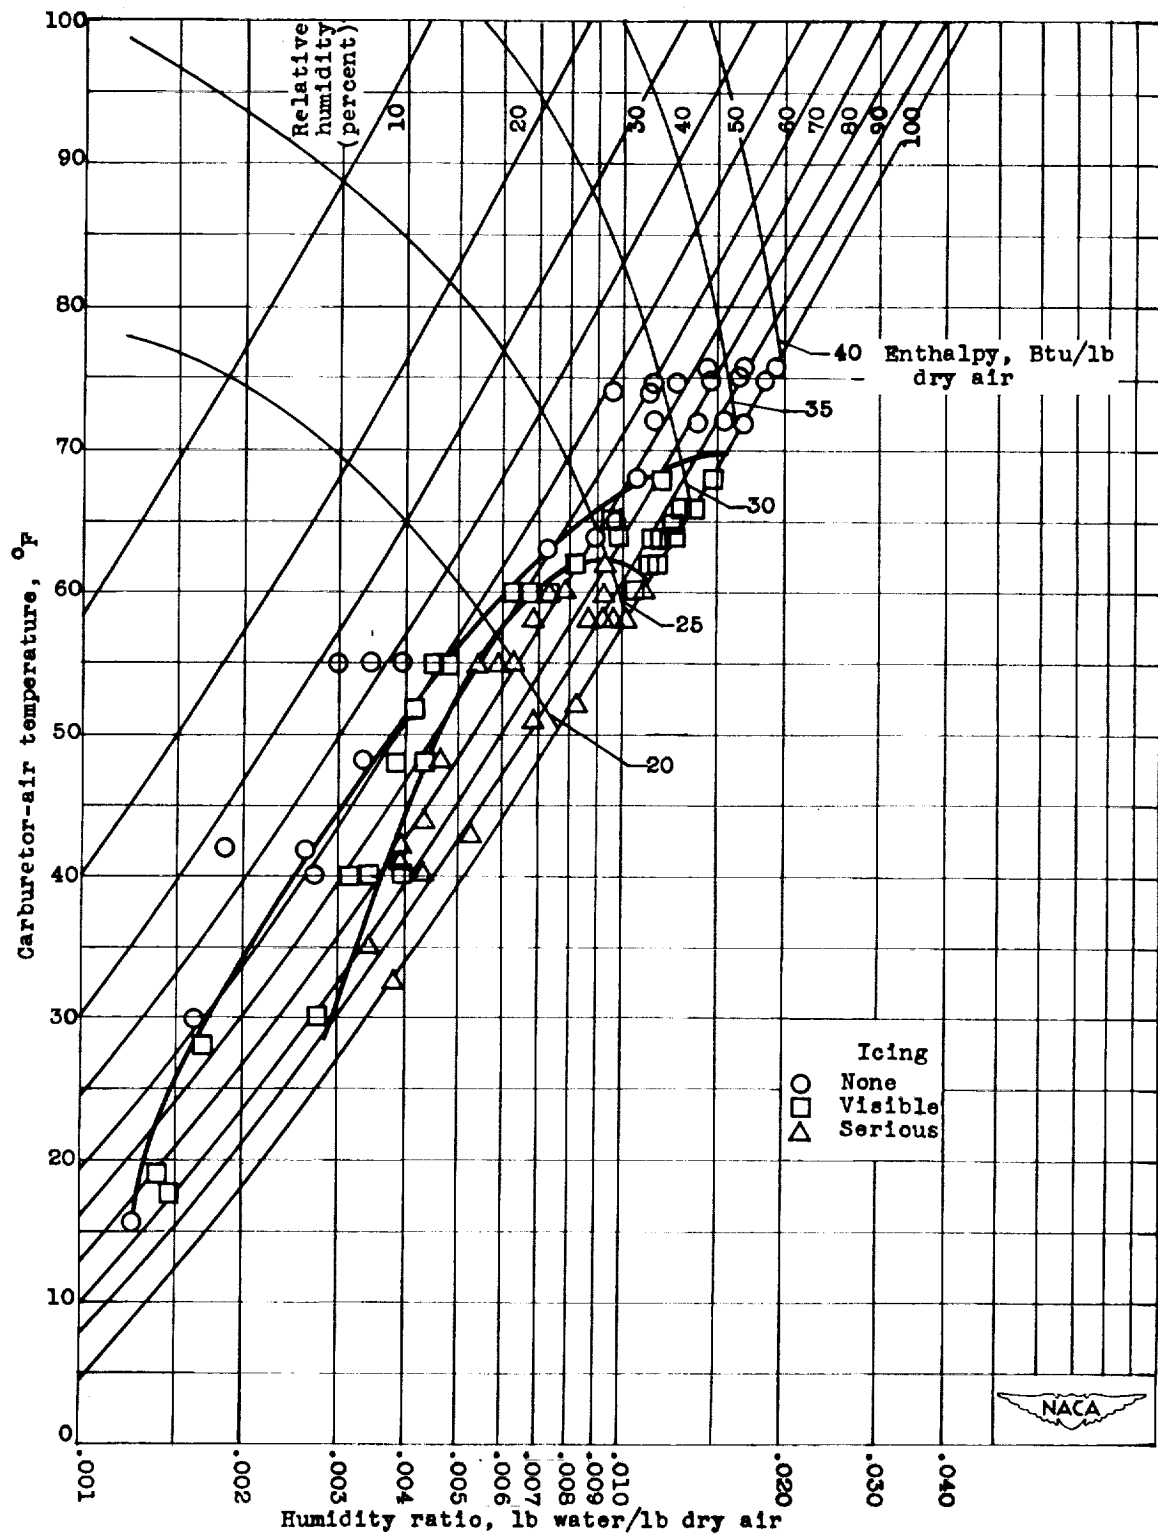
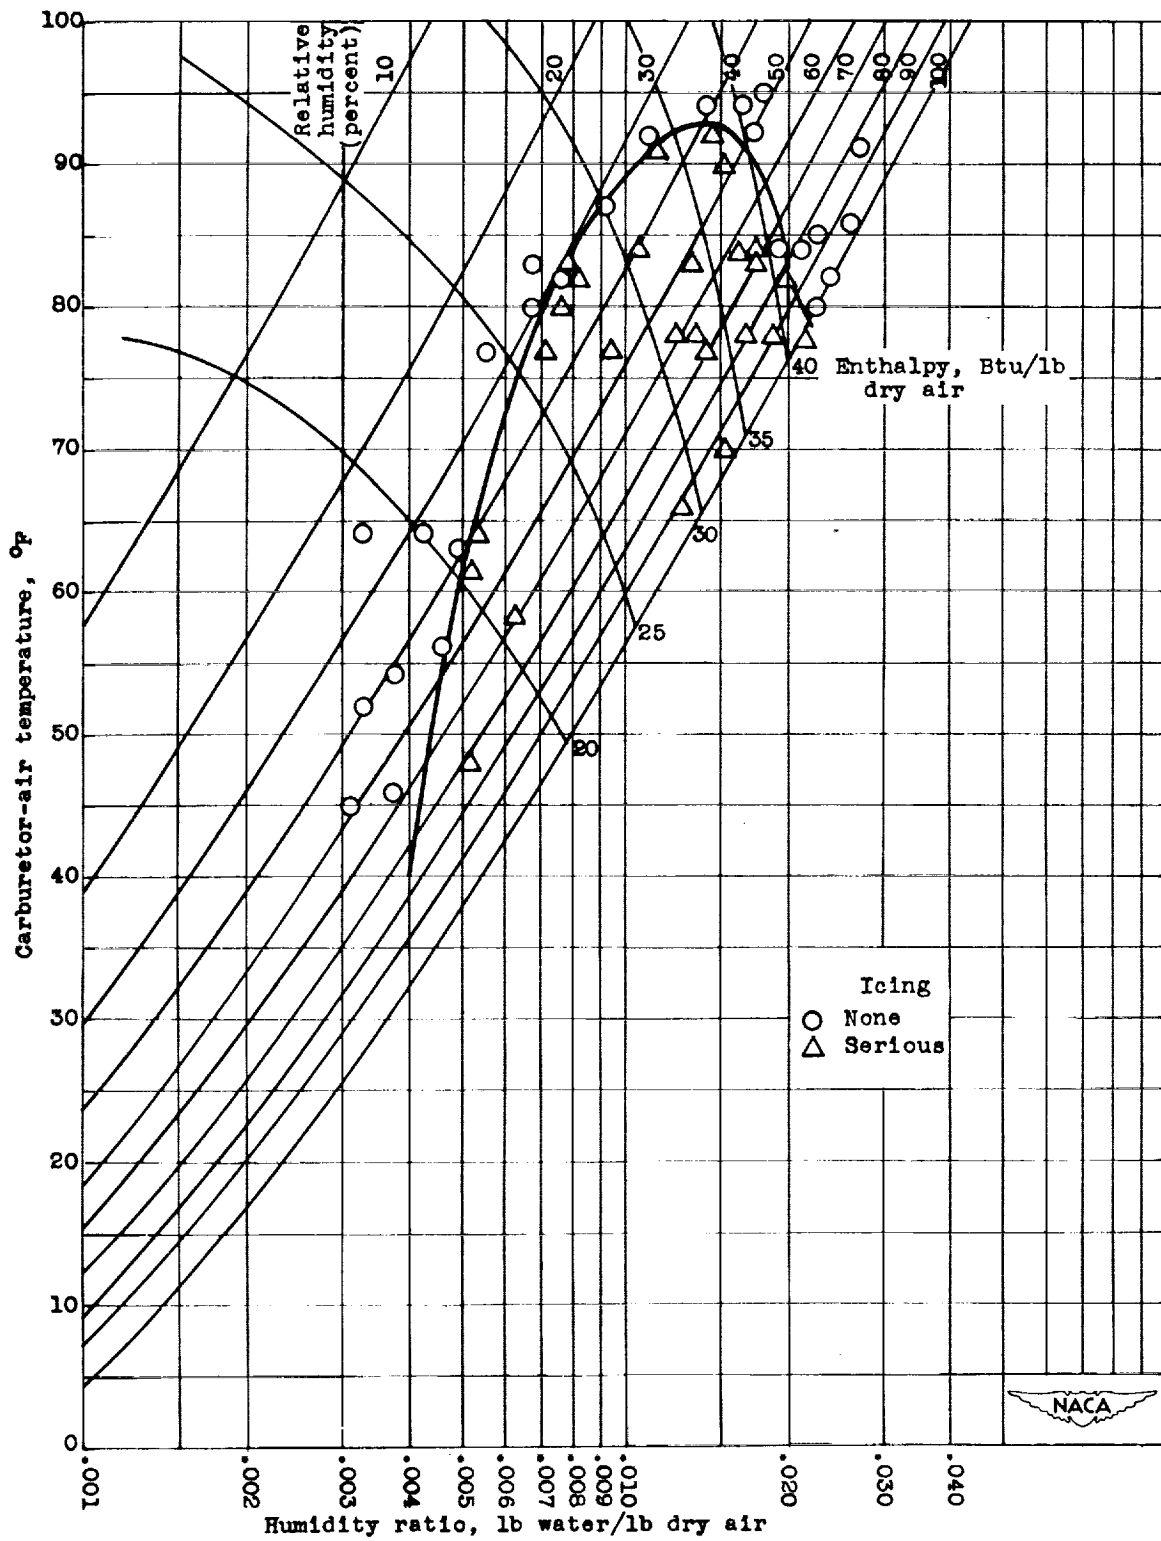
The limits of visible icing and serious icing at various float-type carburetor-air temperatures and humidity ratios for high-cruise, low-cruise, and glide power conditions are shown in figure 5. These data demonstrate the critical effect of throttle opening on icing in the carburetor by the increase in the visible- and serious-icing ranges as the power (and throttle angle) is decreased. At high-cruise power, the upper limit of visible icing occurs at a carburetor-air temperature of approximately 62° F, whereas at low-cruise and glide powers the upper limits occur at approximately 70° and 93° F, respectively. (Visible icing at glide power is designated serious.) For high-cruise, low-cruise, and glide power conditions, the upper limits of air temperature for serious icing are 62° , 63° , and 93° F, and the lower limits of relative humidity are 80, 60, and 30 percent, respectively.

The maximum temperatures at which serious icing was encountered for low-cruise and glide powers occurred at relative humidities less than 100 percent. Further increase in the moisture content at the maximum icing temperature added sufficient heat to the air to reduce the icing limits, as shown by the constant-enthalpy lines in figures 5(b) and 5(c). Figure 5(c) shows that the reduction in the icing limit at high humidity nearly parallels the lines of constant enthalpy. Because the total amount of moisture in the air is small at low temperatures during glide power, the quantity of ice formed may have been so slight that it escaped observation, which accounts for the increased relative humidity at the icing limits for these conditions.

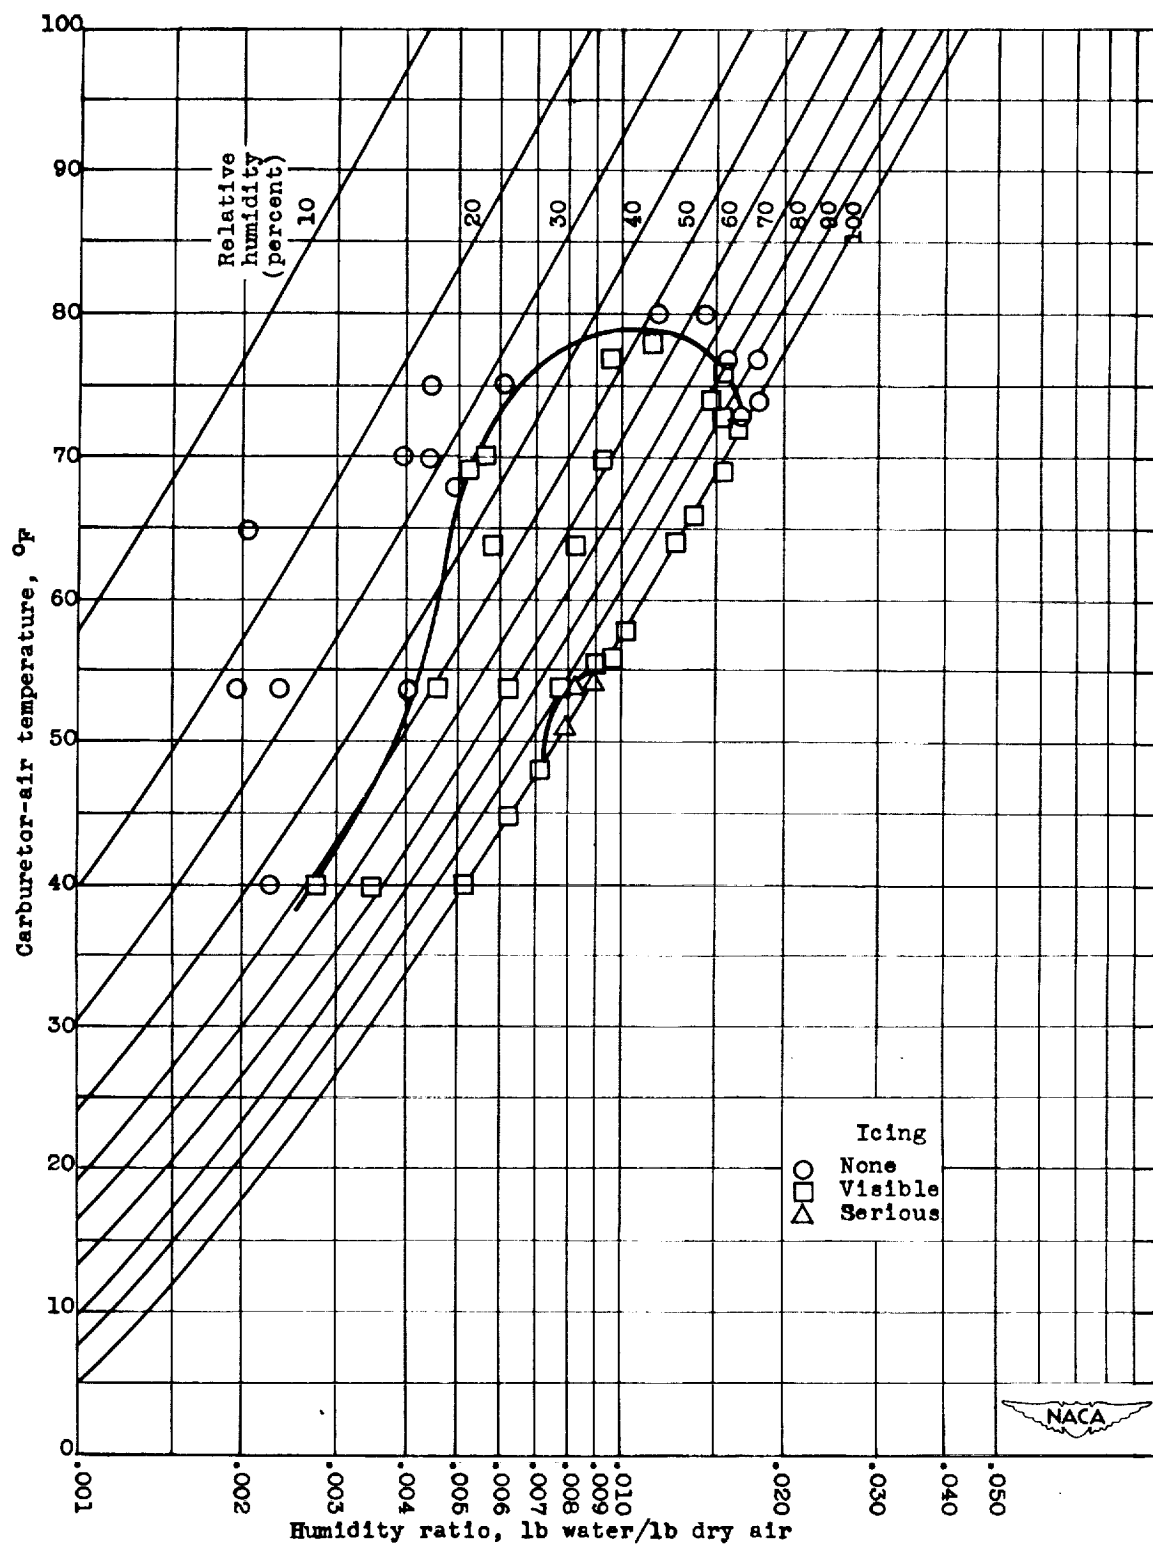
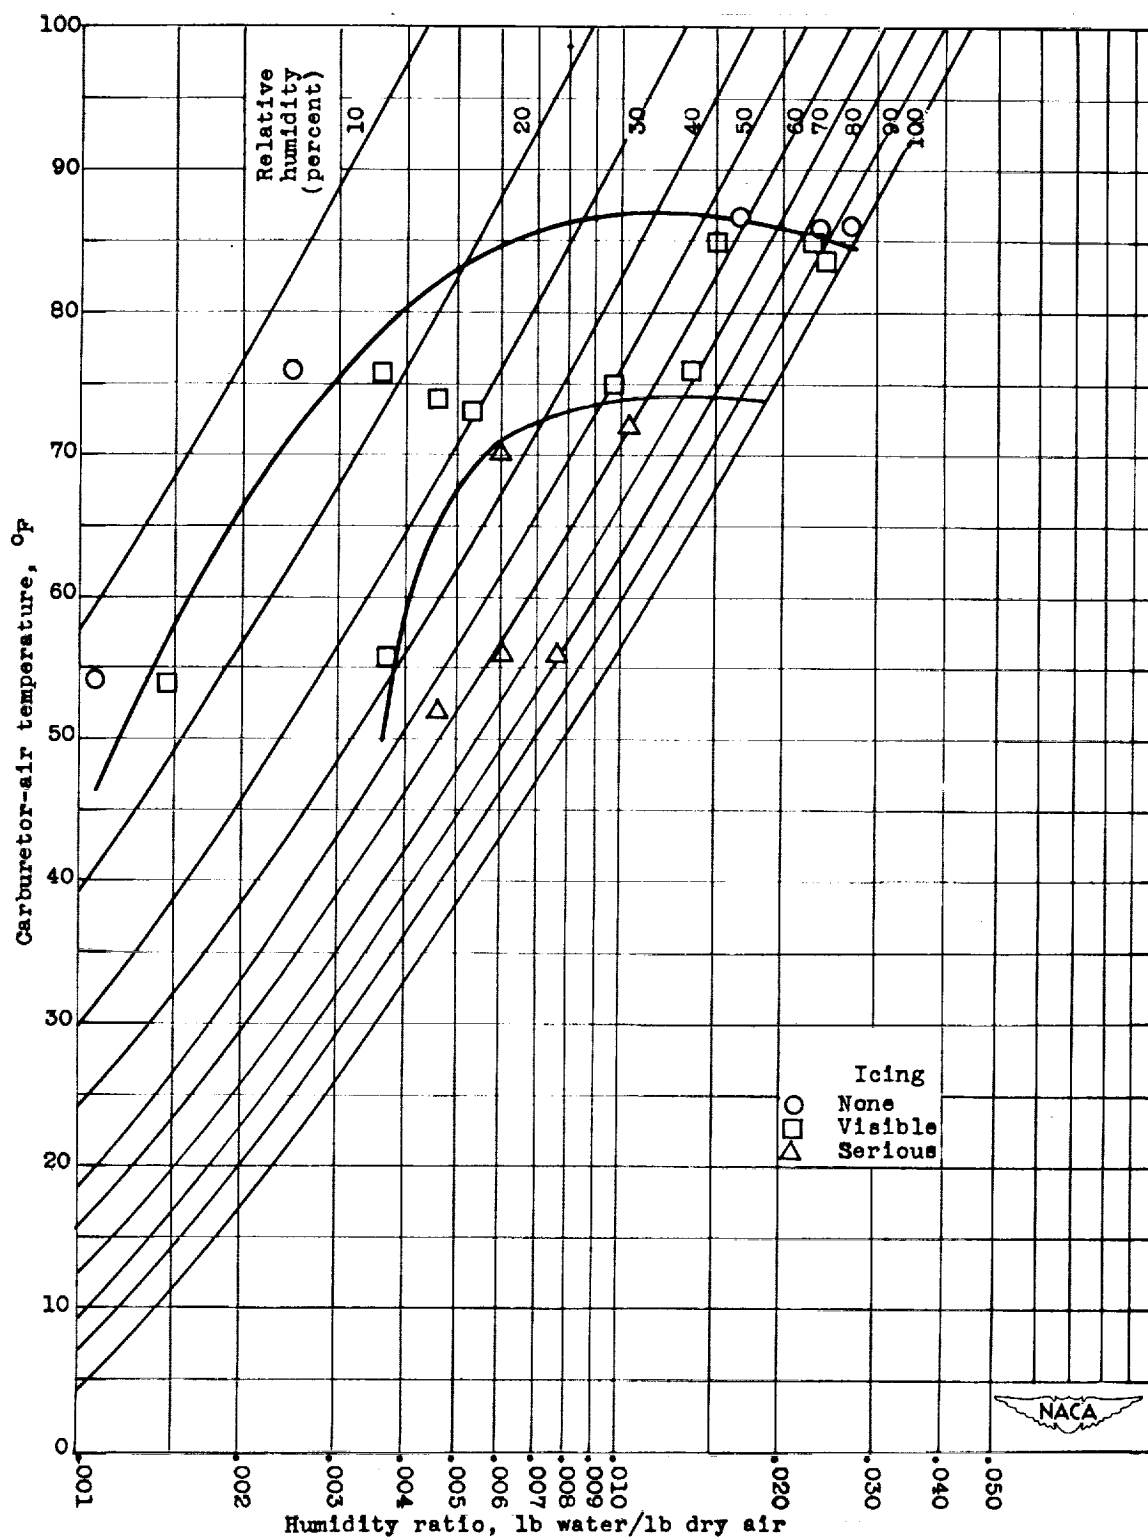
The icing limits for the pressure-type carburetor are shown in figure 6. Only low-cruise and glide power conditions were investigated for this carburetor because critical icing occurred only at the smaller throttle openings. Visible icing was found to occur over a wide range of temperature and humidity. The upper limit of visible ice was 79° F at low-cruise power and 87° F at glide power, with a lower limit of relative humidity at approximately 33 percent for low cruise and approximately 15 percent for glide power. Serious icing was much less extensive for low-cruise power than for glide

power and was confined to a temperature range from 48° to 55° F, with relative humidities from 90 to 100 percent. The limits of serious icing at glide power are seen in figure 6(b) to be approximately 75° F and 32-percent relative humidity. The fuel nozzle in the pressure-type carburetor is located downstream of the throttle. The increase in the range of conditions at which serious ice may form when the throttle is more nearly closed (glide power) is caused by eddying of the fuel spray from the discharge nozzle back to the throttle plate (fig. 3), which results in greatly increased cooling effect by fuel evaporation in the region between the discharge nozzle and the throttle plate.

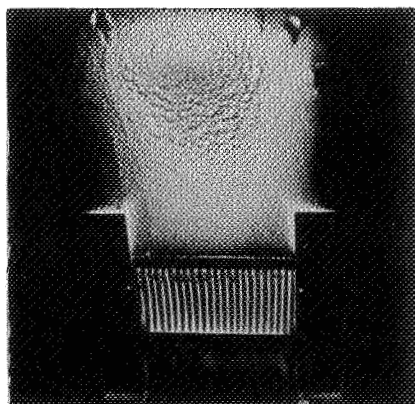
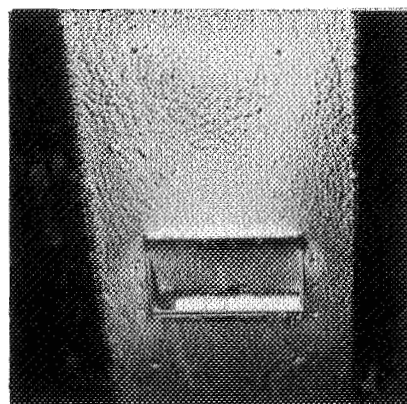
(a) Light-icing conditions.

The modified air scoop effected inertia separation of only the larger water droplets from the charge air, as evidenced by deposits of frost-like ice formations on the filter while heavier ice formations were being deposited on the exposed parts of the air scoop. As shown in the foregoing table, the modified air scoop allowed additional tolerance in time before the predetermined limit of air-flow reduction was reached. Inertia-separation systems for complete ice protection of light-airplane inlets were

Figure 7. - Ice formations on standard and modified carburetor-air inlets for three simulated-icing conditions. Tunnel-air temperature, 17° to 22° F; air velocity, 80 miles per hour.

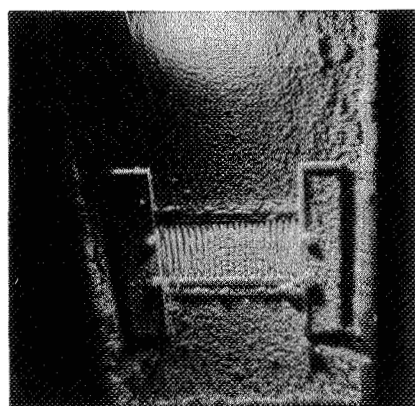
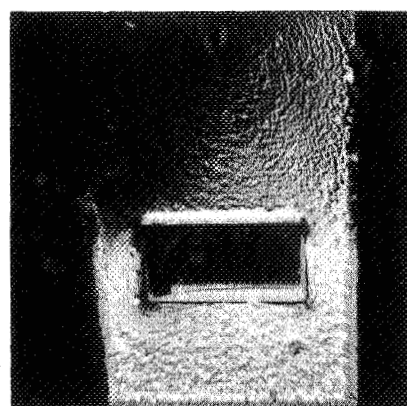
(b) Medium-icing conditions.

Icing to the extent shown on the photographs in figure 7 is not likely to be encountered in light-airplane operation, but is presented as a basis of comparison of the icing characteristics of the two air-scoop configurations. The time for 25-percent reduction in air flow in the preceding table shows that more rapid blocking of the filter took place under the lighter icing conditions because a greater percentage of small droplets was present. Observation of the filters after icing revealed that at the medium and heavy icing conditions, direct impingement and freezing of the water droplets on the ridges and valleys of the filter (cross-sectional view of filter in fig. 4) was primarily responsible for the air-flow reduction, whereas in the light-icing condition the small water droplets were carried with the air stream to all surfaces of the filter and caused more effective blockage.
